Access Compliance Report Public Rights-of-Way (Curb Ramps)

Main Street: NORWOOD_PKWY **Cross Street:** HOLT_AVE **Location:** NE

ADA ID: RPAT211004133650 **Ramp Type:** Type 6 - Directional 1 **Initial Pass/Fail:** Pass **Overall Compliance:** No **Severity Score:** 6

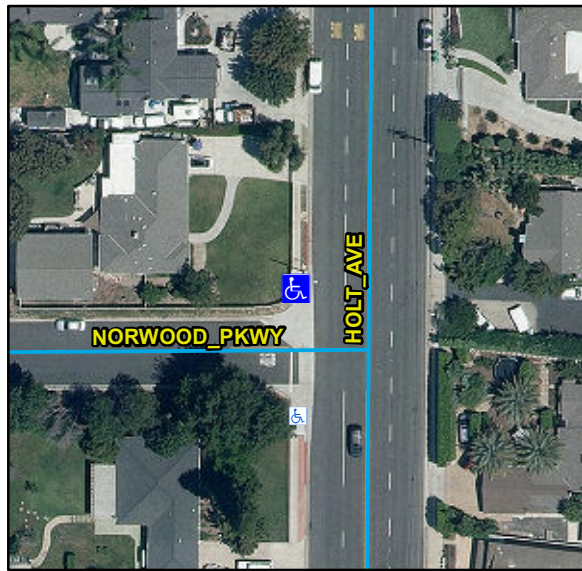
Compliance	Description	Data	Compliance	Description	Data
N/A	Ramp Length (in)	100	Yes	Flare Type LT	
Yes	Ramp Width (in)	70			Curbed2
Yes	Ramp Run Slope (%)	8.2	N/A	Flare Slope LT (%)	N/A
Yes	Ramp Cross Slope (%)	1.5	N/A	Flare Traversable LT	N/A
Yes	Grade Break	Yes	N/A	Flare Type RT	
Yes	Grade Break Slope (%)	0.8			Sloped
Yes	Grade Break Cross Slope (%)	0.4	N/A	Flare Slope RT (%)	N/A
	Addl Para Ramp Left?	No	N/A	Flare Traversable RT	No
	Addl Para Ramp Right?	No	Yes	DWS Provided	Yes
N/A	Landing Present	Yes	Yes	DWS Contrast	Yes
No	Landing Length (in)	44	Yes	DWS Length (in)	36
Yes	Landing Width (in)	86	Yes	DWS Full Width	Yes
No	Landing Run Slope (%)	2.1		DWS Offset Type	Single
Yes	Landing Cross Slope (%)	0.1	No	DWS Left Offset (in)	60
N/A	Landing Movement Obstructed?	No	N/A	DWS Right Offset (in)	0
	Landing Movement Type	N/A			
N/A	Landing Shared	No			
N/A	Marked Crosswalk 1	No	N/A	Clear Space	N/A
	Crossing 1 Direction	S	N/A	Clear Space To Crosswalk (in)	N/A

Marked Crosswalk 1 Width (in)	N/A			
N/A	Ramp Inside Crosswalk 1	N/A			
	Crossing 1 Slope (%)	0.6			
	Crossing 1 Cross Slope (%)	0.6			
Yes	Gutter Ponding	No	Yes	Curb Slope	5.5
Yes	Gutter Lip Height (in)	0		Road Run Slope (%)	N/A
Yes	Gutter Run Slope (%)	1.3		Road Cross Slope (%)	N/A
Yes	Gutter Cross Slope (%)	1.2		Parallel Ramp Side	N/A
Yes	Overall Surface Condition	Acceptable	Yes	Perp Joint Present	Yes
	Cross Gutter Present?	Yes		Spandrel Present?	Yes
	Replace Cross Gutter?	No		Replace Spandrel?	No

Possible Solutions:
Remove & Replace Entire Ramp.

OC Std/PROW:
R304.2.1, R304.2.2-Perp, R304.3.2-Para, R305.2, STD 1115

Total Cost: \$ 3080
