# Access Compliance Report Public Rights-of-Way (Curb Ramps)

Main Street: EHLEN\_WAY Cross Street: MANNING\_DR Location: N

ADA ID: RPAT211004141621 Ramp Type: Type 6 - Directional 1 Initial Pass/Fail: Pass Overall Compliance: No Severity Score: 0

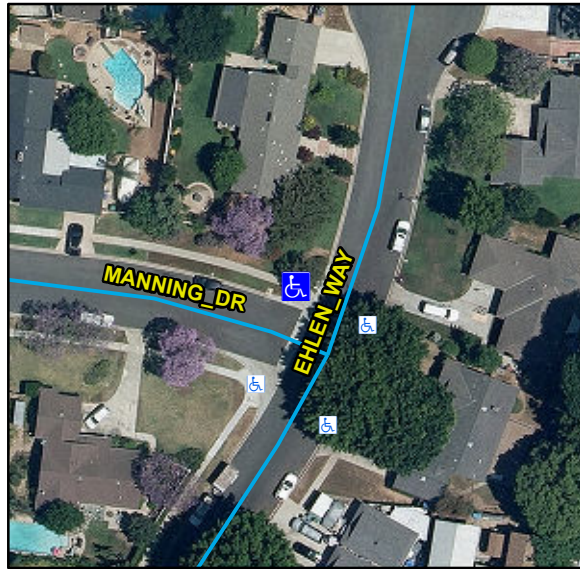
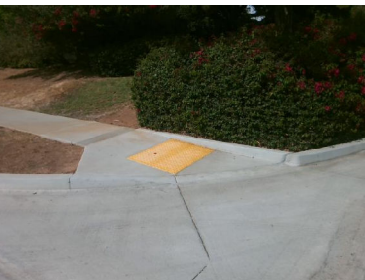
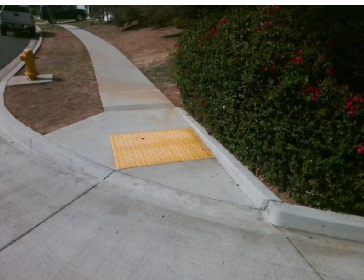
| Compliance | Description | Data | Compliance | Description | Data |
|---|---|---|---|---|---|
| No | Landing Cross Slope (%) | 2.4 | Yes | DWS Left Offset (in) | 0 |
| Yes | Gutter Ponding | No | No | Curb Slope | 8.4 |
| No | Gutter Cross Slope (%) | 2.2 | | Parallel Ramp Side | N/A |

Remove & Replace Entire Ramp. Remove & Replace Gutter.

R304.2.2, R304.5.3, STD 1115

Total Cost: \$ 3332
