# Access Compliance Report Public Rights-of-Way (Curb Ramps)

Main Street: HARP\_CT Cross Street: MANNING\_DR Location: NE

ADA ID: RPAT211004142136 Ramp Type: Type 6 - Directional 1 Initial Pass/Fail: Pass Overall Compliance: No Severity Score: 5

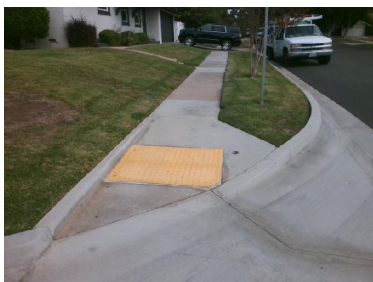
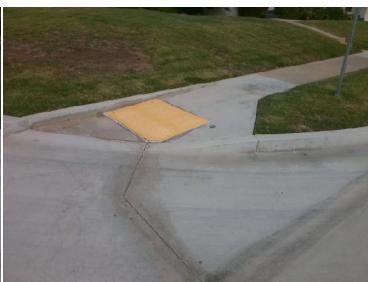
| Compliance | Description | Data | Compliance | Description | Data |
|---|---|---|---|---|---|
| Yes | Gutter Ponding | No | No | Curb Slope | 11.3 |
| No | Gutter Run Slope (%) | 10.4 | | Road Cross Slope (%) | 6.2 |

Remove & Replace Curb Slope. Remove & Replace Gutter.
