# Access Compliance Report Public Rights-of-Way (Curb Ramps)

Main Street: MANNING\_DR Cross Street: HARP\_CT Location: NW

ADA ID: RPAT211004142617 Ramp Type: Type 6 - Directional 1 Initial Pass/Fail: Pass Overall Compliance: No Severity Score: 0

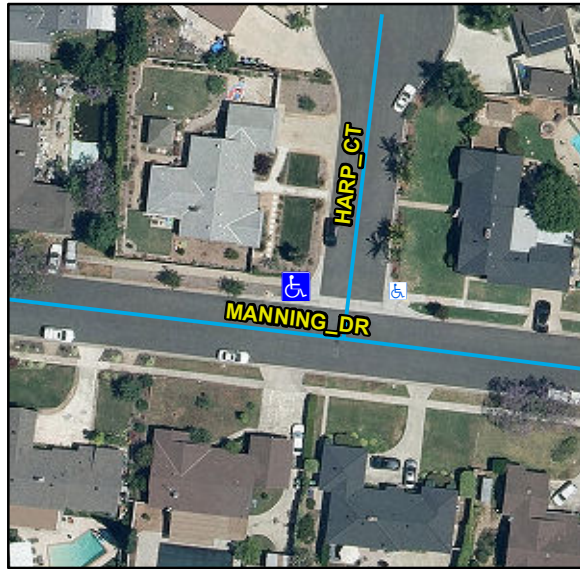
| Compliance | Description | Data | Compliance | Description | Data |
|---|---|---|---|---|---|
| No | Landing Run Slope (%) | 4.1 | | DWS Offset Type | Multiple |
| Yes | Gutter Ponding | No | No | Curb Slope | 10.7 |

Remove & Replace Curb Ramp With Two New Directional Ramps or Equivalent.

R304.2.2, R304.2.2-Perp, R304.3.2-Para, STD 1115
