# Access Compliance Report Public Rights-of-Way (Curb Ramps)

| Main Street: WELLINGTON_AVE | | Cross Street: LAURINDA_WAY | | Location: | NW |
| ADA ID: RPAT211004144904 | Ramp Type: Type 6 - Directional 1 | Initial Pass/Fail: Fail | Overall Compliance: No | Severity Score: | 2 |

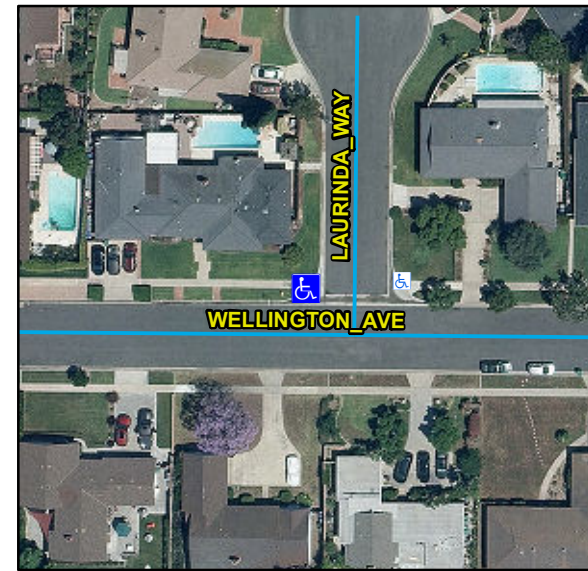
| Compliance | Description | Data | Compliance | Description | Data |
|---|---|---|---|---|---|
| No | Ramp Cross Slope (%) | 2.2 | N/A | Flare Traversable LT | N/A |

**Remove & Replace Curb Ramp With Two New Directional Ramps or Equivalent.**

**R304.5.3, STD 1115**
