# Access Compliance Report Public Rights-of-Way (Curb Ramps)

Main Street: LAURINDA\_WAY Cross Street: WELLINGTON\_AVE Location: NE

ADA ID: RPAT211004145642 Ramp Type: Type 6 - Directional 1 Initial Pass/Fail: Pass Overall Compliance: No Severity Score: 6

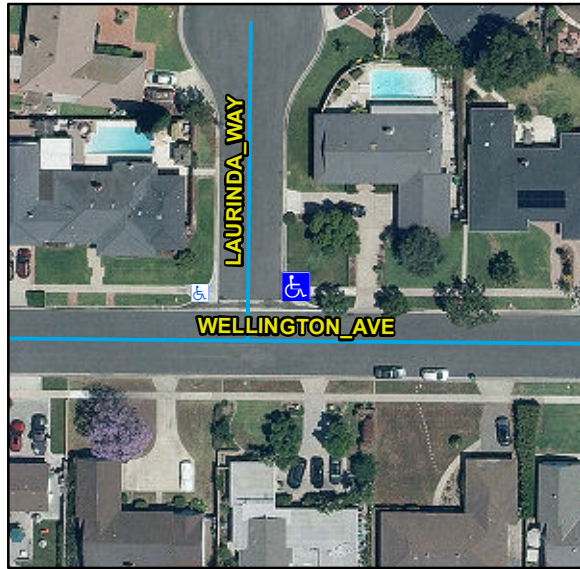
| Compliance | Description | Data | Compliance | Description | Data |
|---|---|---|---|---|---|
| N/A | Ramp Length (in) | 94 | Yes | Flare Type LT | Curbed2 |
| Yes | Ramp Width (in) | 48 | | | |
| Yes | Ramp Run Slope (%) | 6.8 | N/A | Flare Slope LT (%) | N/A |
| Yes | Ramp Cross Slope (%) | 1.6 | N/A | Flare Traversable LT | N/A |

Remove & Replace Curb Ramp With Two New Directional Ramps or Equivalent.

R304.2.2, R304.2.1, STD 1115

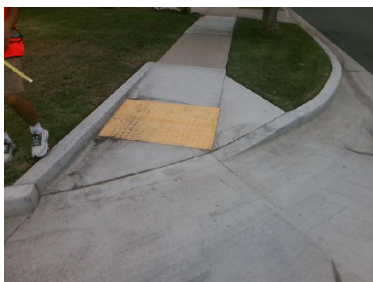
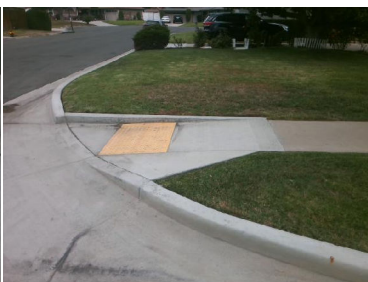
| Compliance | Description | Data | Compliance | Description | Data |
|---|---|---|---|---|---|
| No | Landing Width (in) | 47 | Yes | DWS Full Width | Yes |
| Yes | Gutter Ponding | No | No | Curb Slope | 9.1 |
