# Access Compliance Report Public Rights-of-Way (Curb Ramps)

Main Street: HOWLAND\_WAY Cross Street: WELLINGTON\_AVE Location: NE

ADA ID: RPAT211004150348 Ramp Type: Type 6 - Directional 1 Initial Pass/Fail: Fail Overall Compliance: No Severity Score: 19

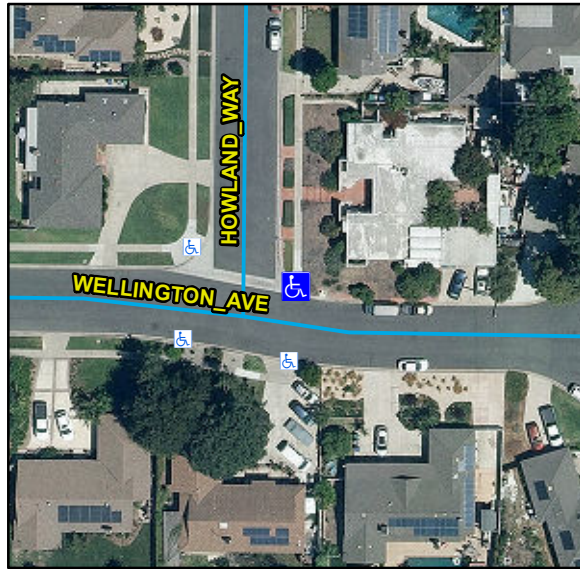
| Compliance | Description | Data | Compliance | Description | Data |
|---|---|---|---|---|---|
| No | Ramp Width (in) | 47 | | | N/A |
| No | Overall Surface Condition | Poor | Yes | Perp Joint Present | Yes |

**Remove & Replace Curb Ramp With Two New Directional Ramps or Equivalent.**

**R304.5.1, R302.7, STD 1115**
