# Access Compliance Report Public Rights-of-Way (Curb Ramps)

Main Street: **HOWLAND\_WAY** Cross Street: **FIESTA\_WAY** Location: **NE**

ADA ID: **RPAT211004151600** Ramp Type: **Type 6 - Directional 1** Initial Pass/Fail: **Fail** Overall Compliance: **No** Severity Score: **5**

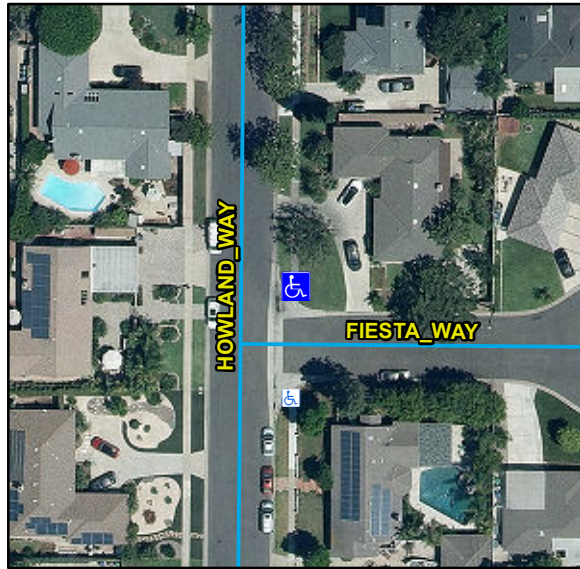
| Compliance | Description | Data | Compliance | Description | Data |
|---|---|---|---|---|---|
| <b>No</b> | Ramp Width (in) | <b>44</b> | | | <b>N/A</b> |
| <b>No</b> | Ramp Cross Slope (%) | <b>2.6</b> | <b>N/A</b> | Flare Traversable LT | <b>N/A</b> |

**Remove & Replace Curb Ramp With Two New Directional Ramps or Equivalent.**

**R304.5.1, R304.5.3, STD 1115**

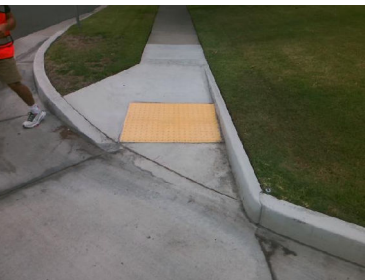
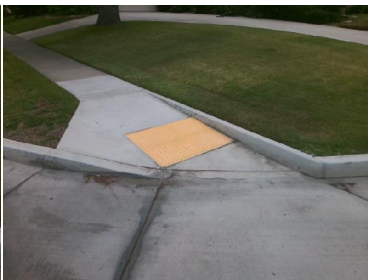
| Compliance | Description | Data | Compliance | Description | Data |
|---|---|---|---|---|---|
| <b>Yes</b> | Overall Surface Condition | <b>Acceptable</b> | <b>Yes</b> | Perp Joint Present | <b>Yes</b> |
