# Access Compliance Report Public Rights-of-Way (Curb Ramps)

Main Street: HOWLAND\_WAY Cross Street: ARBOLADA\_WAY Location: SW

ADA ID: RPAT211004151843 Ramp Type: Type 1 - Perpendicular Diagonal Initial Pass/Fail: Fail Overall Compliance: No Severity Score: 2

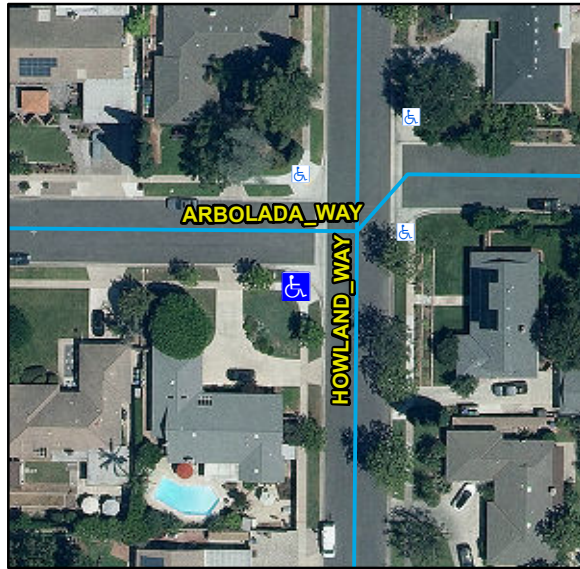
| Compliance | Description | Data | Compliance | Description | Data |
|---|---|---|---|---|---|
| No | Ramp Cross Slope (%) | 2.1 | N/A | Flare Traversable LT | N/A |

**Remove & Replace Curb Ramp With Two New Directional Ramps or Equivalent.**

**R304.2.2, R304.5.3, STD 1115**

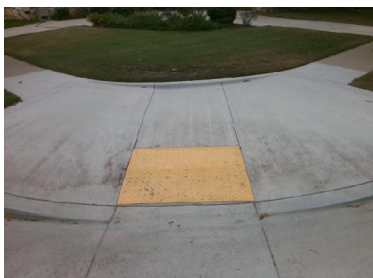
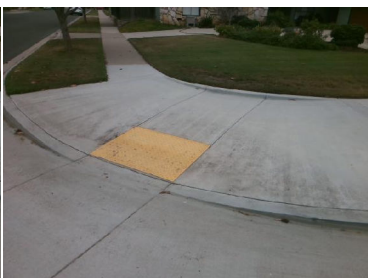
| Compliance | Description | Data | Compliance | Description | Data |
|---|---|---|---|---|---|
| N/A | Gutter Ponding | N/A | No | Curb Slope | 8.4 |
