# Access Compliance Report Public Rights-of-Way (Curb Ramps)

Main Street: HOWLAND\_WAY Cross Street: ARBOLADA\_WAY Location: NE

ADA ID: RPAT211004152449 Ramp Type: Type 6 - Directional 1 Initial Pass/Fail: Fail Overall Compliance: No Severity Score: 4

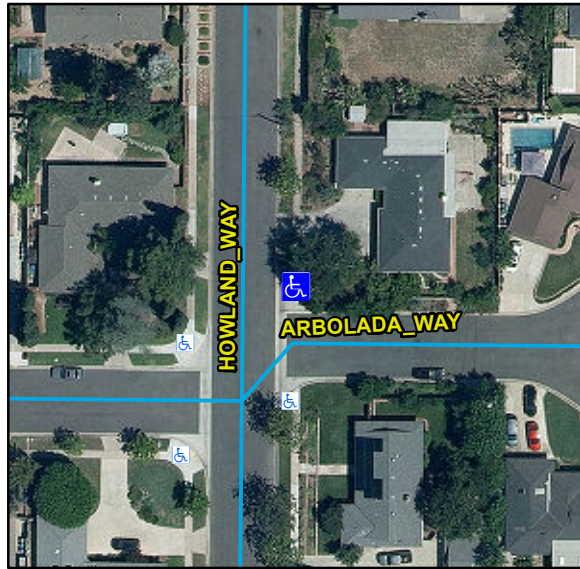
| Compliance | Description | Data | Compliance | Description | Data |
|---|---|---|---|---|---|
| No | Ramp Width (in) | 43 | | | N/A |

**Remove & Replace Curb Ramp With Two New Directional Ramps or Equivalent.**

**R304.5.1, STD 1115**
