# Access Compliance Report Public Rights-of-Way (Curb Ramps)

Main Street: ARBOLADA\_WAY Cross Street: HOWLAND\_WAY Location: SE

ADA ID: RPAT211004152755 Ramp Type: Type 6 - Directional 1 Initial Pass/Fail: Fail Overall Compliance: No Severity Score: 5

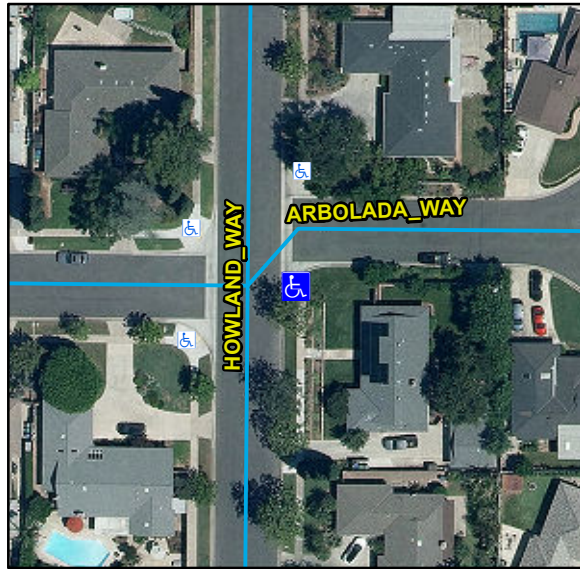
| Compliance | Description | Data | Compliance | Description | Data |
|---|---|---|---|---|---|
| No | Ramp Width (in) | 44 | | | N/A |

**Remove & Replace Curb Ramp With Two New Directional Ramps or Equivalent.**

**R304.5.1, STD 1115**
