# Access Compliance Report Public Rights-of-Way (Curb Ramps)

Main Street: ST\_MORITZ\_CIR Cross Street: OLYMPIA\_WAY Location: SE

ADA ID: RPAT211005084259 Ramp Type: Type 1 - Perpendicular Diagonal Initial Pass/Fail: Fail Overall Compliance: No Severity Score: 2

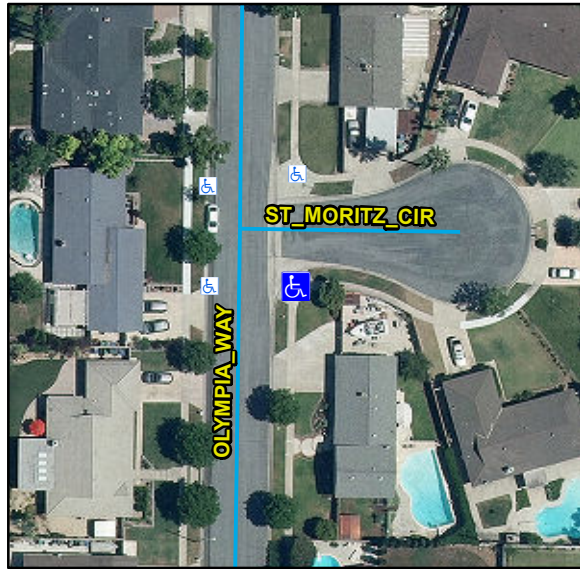
## Field Measurements/Component Compliance

Remove & Replace Curb Ramp With Two New Directional Ramps or Equivalent.

R304.2.2, STD 1115

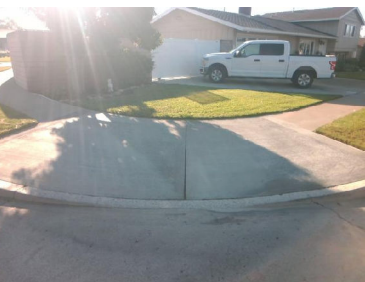
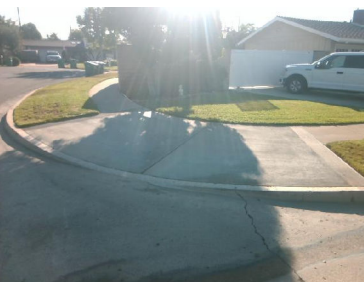
| Compliance | Description | Data | Compliance | Description | Data |
|---|---|---|---|---|---|
| Yes | Overall Surface Condition: Acceptable | | Yes | Perp Joint Present | Yes |
