# Access Compliance Report Public Rights-of-Way (Curb Ramps)

Main Street: OLYMPIA\_WAY Cross Street: ST\_MORITZ\_CIR Location: NE

ADA ID: RPAT211005084611 Ramp Type: Type 1 - Perpendicular Diagonal Initial Pass/Fail: Pass Overall Compliance: No Severity Score: 22

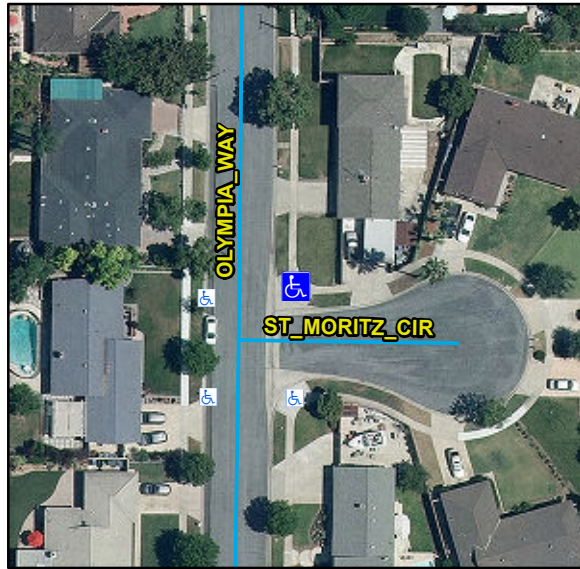
| Compliance | Description | Data | Compliance | Description | Data |
|---|---|---|---|---|---|
| No | Landing Width (in) | N/A | N/A | Flare Slope RT (%) | 7.1 |
| No | Landing Run Slope (%) | N/A | N/A | Flare Traversable RT | No |
| No | Landing Cross Slope (%) | N/A | No | DWS Provided | No |

Remove & Replace Curb Ramp With Two New Directional Ramps or Equivalent.
