# Access Compliance Report Public Rights-of-Way (Curb Ramps)

Main Street: E\_DIXON\_AVE Cross Street: OLYMPIA\_WAY Location: SE

ADA ID: RPAT211005084950 Ramp Type:Type 1 - Perpendicular Diagonal Initial Pass/Fail: Pass Overall Compliance: No Severity Score: 20

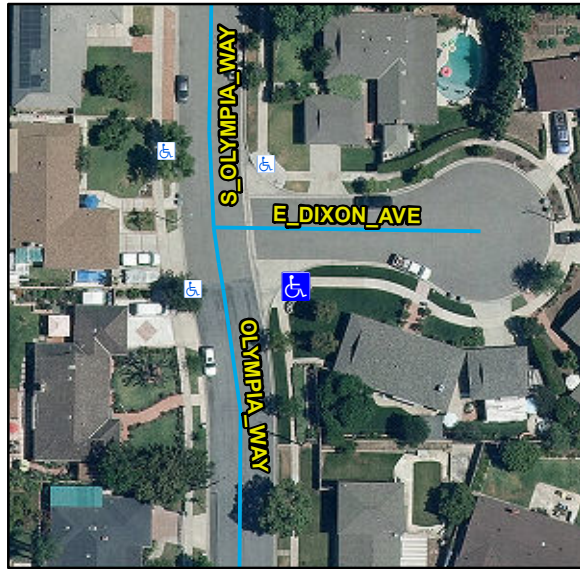
R304.2.2, R304.2.1, R304.2.2-Perp, R304.3.2-Para, R304.5.3, R305, STD 1115

Remove & Replace Curb Ramp With Two New Directional Ramps or Equivalent.

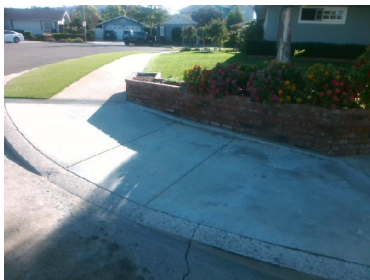
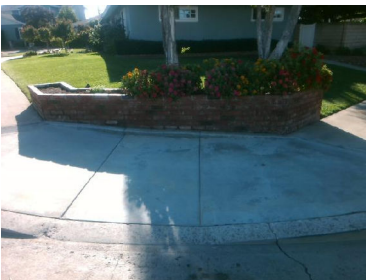
| Compliance | Description | Data | Compliance | Description | Data |
|---|---|---|---|---|---|
| No | Landing Width (in) | N/A | N/A | Flare Slope RT (%) | 4 |
| No | Landing Run Slope (%) | N/A | N/A | Flare Traversable RT | No |
| No | Landing Cross Slope (%) | N/A | No | DWS Provided | No |
| Yes | Gutter Ponding | No | No | Curb Slope | 15 |
