# Access Compliance Report Public Rights-of-Way (Curb Ramps)

Main Street: OLYMPIA\_WAY Cross Street: LARKSTONE\_DR Location: NE

ADA ID: RPAT211005090152 Ramp Type: Type 1 - Perpendicular Diagonal Initial Pass/Fail: Pass Overall Compliance: No Severity Score: 22

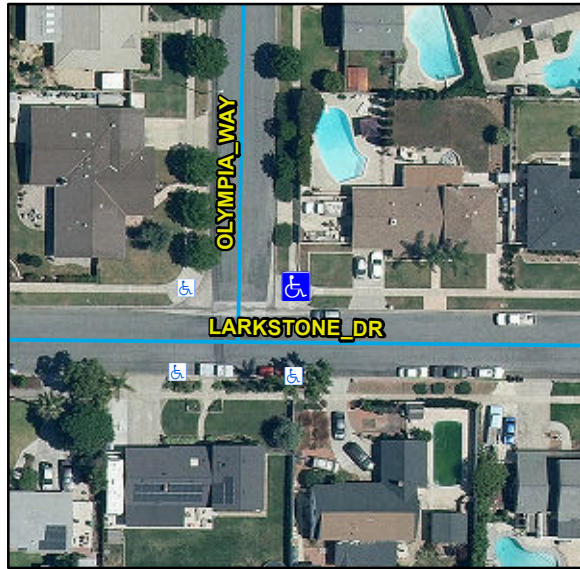
| Compliance | Description | Data | Compliance | Description | Data |
|---|---|---|---|---|---|
| No | Landing Width (in) | N/A | N/A | Flare Slope RT (%) | 4.9 |
| No | Landing Run Slope (%) | N/A | N/A | Flare Traversable RT | No |
| No | Landing Cross Slope (%) | N/A | No | DWS Provided | No |
| N/A | Landing Movement Obstructed? | Yes | N/A | DWS Contrast | N/A |
| | Landing Movement Type | Wall | N/A | DWS Length (in) | N/A |
| Yes | Gutter Ponding | No | No | Curb Slope | 10.6 |

**Remove & Replace Curb Ramp With Two New Directional Ramps or Equivalent.**

**R304.2.2, R204.3, R304.2.1, R304.2.2-Perp, R304.3.2-Para, R304.5.3, R305, STD 1115**

Total Cost: \$ 6160
