# Access Compliance Report Public Rights-of-Way (Curb Ramps)

Main Street: LARKSTONE\_DR Cross Street: OLYMPIA\_WAY Location: NW

ADA ID: RPAT211005090702 Ramp Type: Type 1 - Perpendicular Diagonal Initial Pass/Fail: Pass Overall Compliance: No Severity Score: 22

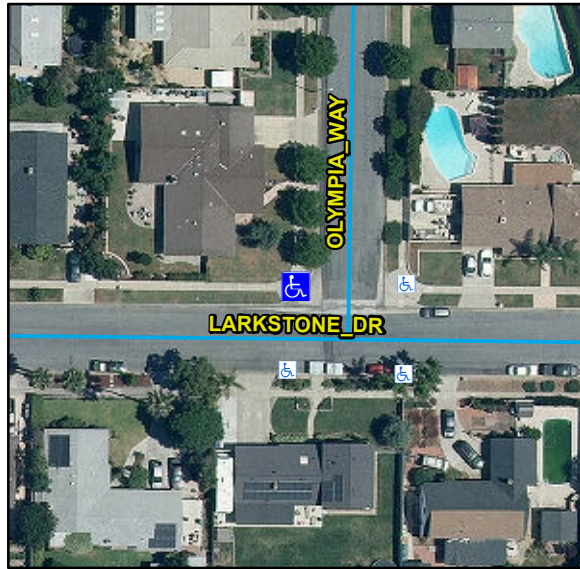
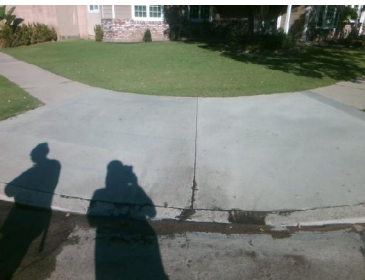
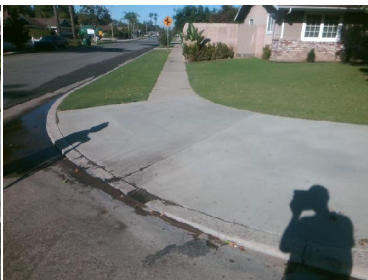
| Compliance | Description | Data | Compliance | Description | Data |
|---|---|---|---|---|---|
| No | Landing Width (in) | N/A | N/A | Flare Slope RT (%) | 6.8 |
| No | Landing Run Slope (%) | N/A | N/A | Flare Traversable RT | No |
| No | Landing Cross Slope (%) | N/A | No | DWS Provided | No |
| Yes | Gutter Ponding | No | No | Curb Slope | 7.4 |

**Remove & Replace Curb Ramp With Two New Directional Ramps or Equivalent.**

**R304.2.2, R204.3, R304.2.1, R304.2.2-Perp, R304.3.2-Para, R304.5.3, R305, STD 1115**
