# Access Compliance Report Public Rights-of-Way (Curb Ramps)

Main Street: DUNAS\_RD Cross Street: LARKSTONE\_DR Location: NE

ADA ID: RPAT211005091240 Ramp Type: Type 1 - Perpendicular Diagonal Initial Pass/Fail: Pass Overall Compliance: No Severity Score: 20

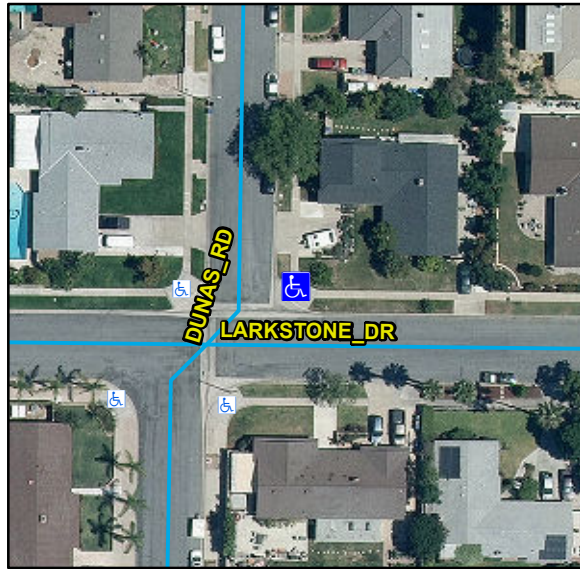
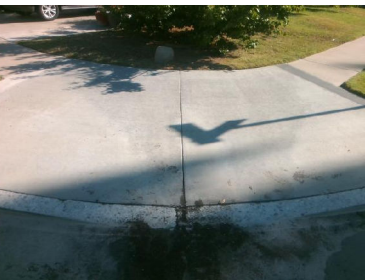
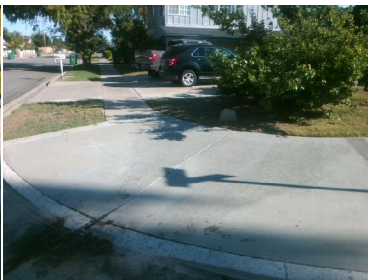
| Compliance | Description | Data | Compliance | Description | Data |
|---|---|---|---|---|---|
| No | Landing Width (in) | N/A | N/A | Flare Slope RT (%) | 4.4 |
| No | Landing Run Slope (%) | N/A | N/A | Flare Traversable RT | No |
| No | Landing Cross Slope (%) | N/A | No | DWS Provided | No |
| Yes | Gutter Ponding | No | No | Curb Slope | 7.8 |

**Remove & Replace Curb Ramp With Two New Directional Ramps or Equivalent.**
