# Access Compliance Report Public Rights-of-Way (Curb Ramps)

Main Street: LARKSTONE\_DR Cross Street: DUNAS\_RD Location: NW

ADA ID: RPAT211005091633 Ramp Type: Type 1 - Perpendicular Diagonal Initial Pass/Fail: Pass Overall Compliance: No Severity Score: 22

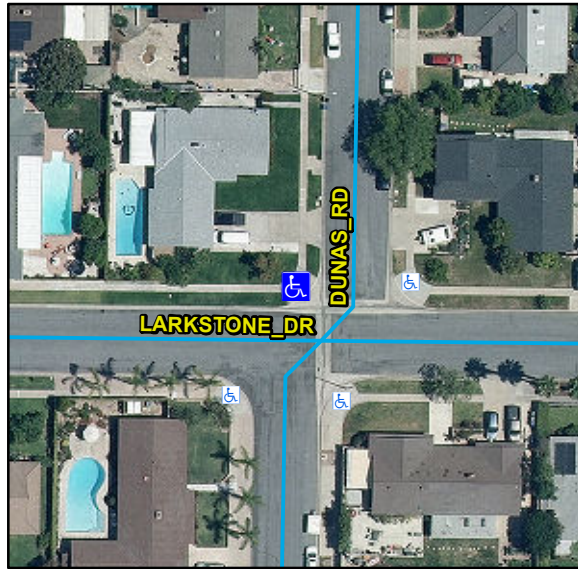
R304.2.2, R204.3, R304.2.1, R304.2.2-Perp, R304.3.2-Para, R304.5.3, R305, STD 1115

Remove & Replace Curb Ramp With Two New Directional Ramps or Equivalent.
