# Access Compliance Report Public Rights-of-Way (Curb Ramps)

Main Street: LARKSTONE\_DR Cross Street: DUNAS\_RD Location: SE

ADA ID: RPAT211005092027 Ramp Type: Type 1 - Perpendicular Diagonal Initial Pass/Fail: Fail Overall Compliance: No Severity Score: 5

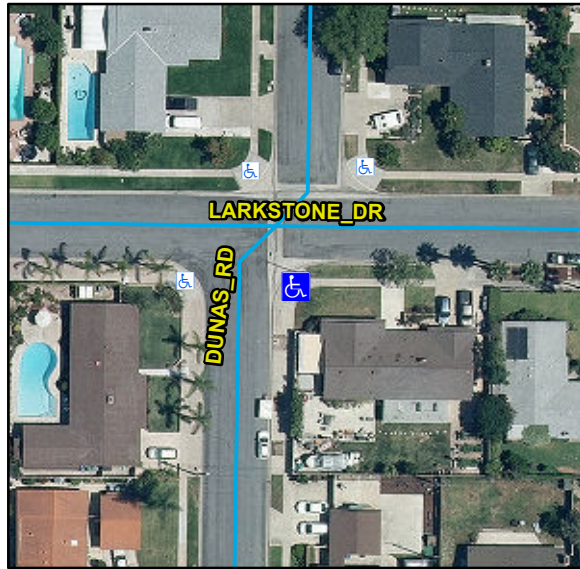
| Compliance | Description | Data | Compliance | Description | Data |
|---|---|---|---|---|---|
| No | Ramp Width (in) | 47 | | | N/A |

Remove & Replace Curb Ramp With Two New Directional Ramps or Equivalent.

R304.2.2, R304.5.1, STD 1115
