# Access Compliance Report Public Rights-of-Way (Curb Ramps)

Main Street: DUNAS\_RD Cross Street: LARKSTONE\_DR Location: SW

ADA ID: RPAT211005092410 Ramp Type: Type 1 - Perpendicular Diagonal Initial Pass/Fail: Fail Overall Compliance: No Severity Score: 5

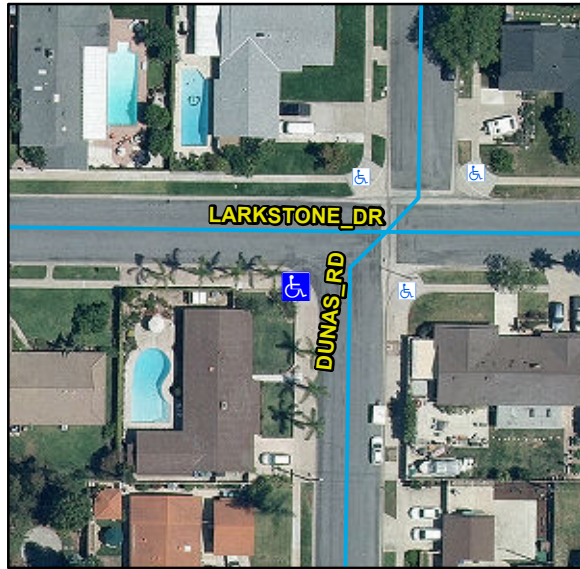
| Compliance | Description | Data | Compliance | Description | Data |
|---|---|---|---|---|---|
| No | Ramp Width (in) | 47 | | | N/A |
| No | Ramp Cross Slope (%) | 2.8 | N/A | Flare Traversable LT | N/A |

Remove & Replace Curb Ramp With Two New Directional Ramps or Equivalent.
