# Access Compliance Report Public Rights-of-Way (Curb Ramps)

Main Street: SHASTA\_WAY Cross Street: LARKSTONE\_DR Location: NE

ADA ID: RPAT211005092737 Ramp Type: Type 1 - Perpendicular Diagonal Initial Pass/Fail: Pass Overall Compliance: No Severity Score: 26

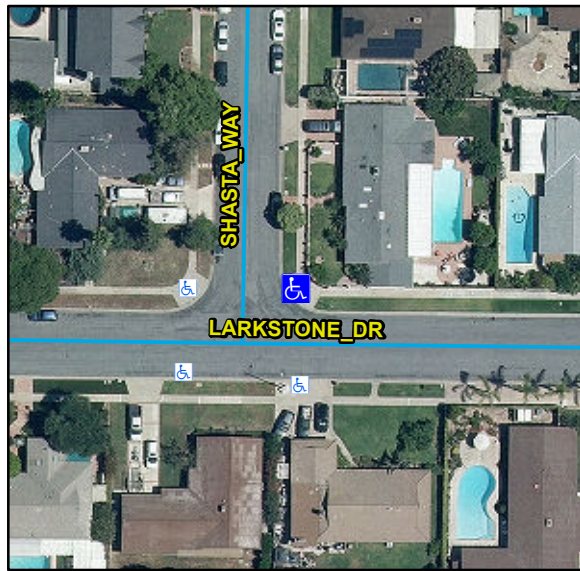
| Compliance | Description | Data | Compliance | Description | Data |
|---|---|---|---|---|---|
| No | Landing Cross Slope (%) | N/A | No | DWS Provided | No |
| Yes | Gutter Ponding | No | No | Curb Slope | 5.2 |
| No | Gutter Run Slope (%) | 6.6 | | Road Cross Slope (%) | 9 |

Remove & Replace Curb Ramp With Two New Directional Ramps or Equivalent. Remove & Replace Gutter.
