# Access Compliance Report Public Rights-of-Way (Curb Ramps)

Main Street: LARKSTONE\_DR Cross Street: SHASTA\_WAY Location: NW

ADA ID: RPAT211005093103 Ramp Type: Type 1 - Perpendicular Diagonal Initial Pass/Fail: Fail Overall Compliance: No Severity Score: 2

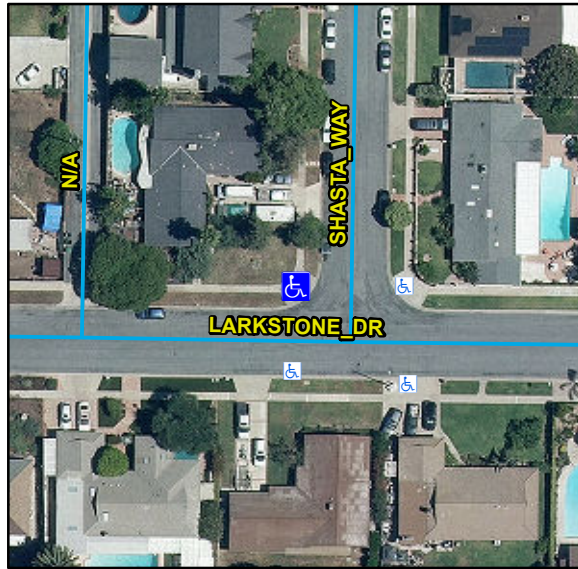
| Compliance | Description | Data | Compliance | Description | Data |
|---|---|---|---|---|---|
| No | Ramp Cross Slope (%) | 2.9 | N/A | Flare Traversable LT | N/A |
| N/A | Gutter Ponding | N/A | No | Curb Slope | 7.2 |

Remove & Replace Curb Ramp With Two New Directional Ramps or Equivalent.

R304.2.2, R304.5.3, STD 1115
