# Access Compliance Report Public Rights-of-Way (Curb Ramps)

Main Street: S\_PROSPECT\_ST Cross Street: LARKSTONE\_DR Location: NE

ADA ID: RPAT211005093553 Ramp Type: Type 1 - Perpendicular Diagonal Initial Pass/Fail: Fail Overall Compliance: No Severity Score: 16

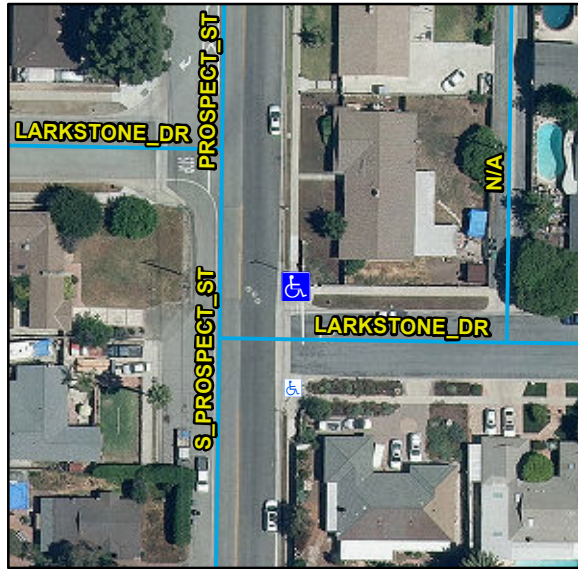
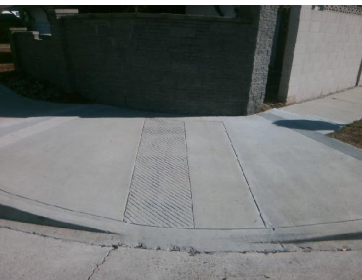
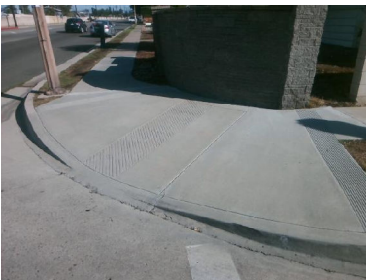
R304.2.2, R304.5.3, STD 1115

| Compliance | Description | Data | Compliance | Description | Data |
|---|---|---|---|---|---|
| No | Ramp Run Slope (%) | 11 | N/A | Flare Slope LT (%) | N/A |
| No | Ramp Cross Slope (%) | 2.4 | N/A | Flare Traversable LT | N/A |

Remove & Replace Curb Ramp With Two New Directional Ramps or Equivalent.
