# Access Compliance Report Public Rights-of-Way (Curb Ramps)

| Main Street: LARKSTONE_DR | | Cross Street: S_PROSPECT_ST | | Location: | SE |
| ADA ID: RPAT211005094003 | Ramp Type:Type 1 - Perpendicular | Initial Pass/Fail: Fail | Overall Compliance: No | Severity Score: | 16 |

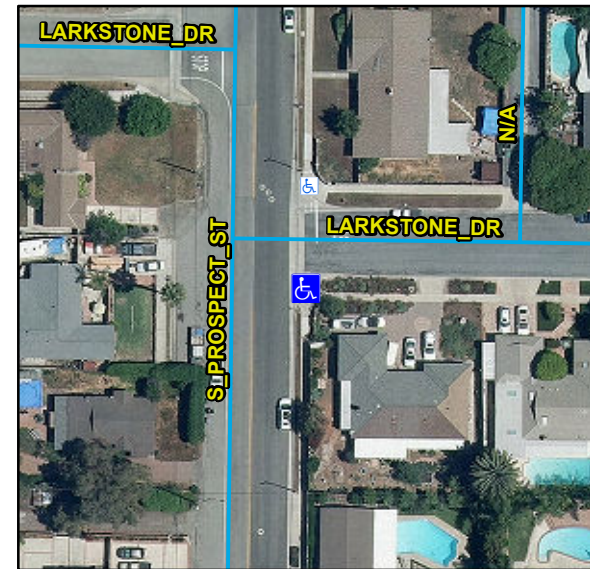
| Compliance | Description | Data | Compliance | Description | Data |
|---|---|---|---|---|---|
| No | Ramp Run Slope (%) | 9.5 | N/A | Flare Slope LT (%) | N/A |
| No | Ramp Cross Slope (%) | 3.6 | N/A | Flare Traversable LT | N/A |

Possible Solutions:

Remove & Replace Entire Ramp.
