# Access Compliance Report Public Rights-of-Way (Curb Ramps)

Main Street: E CASSELLE\_AVE Cross Street: DUNAS\_RD Location: NW

ADA ID: RPAT211005094512 Ramp Type: Type 1 - Perpendicular Diagonal Initial Pass/Fail: Pass Overall Compliance: No Severity Score: 26

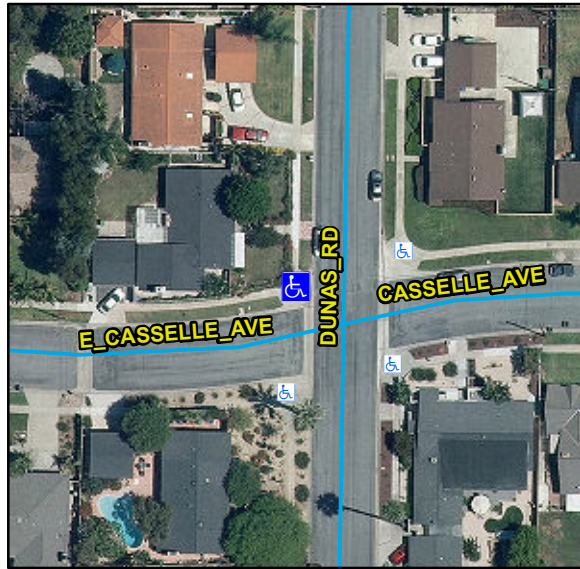
| Compliance | Description | Data | Compliance | Description | Data |
|---|---|---|---|---|---|
| No | Landing Width (in) | N/A | N/A | Flare Slope RT (%) | 4.2 |
| No | Landing Run Slope (%) | N/A | N/A | Flare Traversable RT | No |
| No | Landing Cross Slope (%) | N/A | No | DWS Provided | No |
| Yes | Gutter Ponding | No | No | Curb Slope | 8.9 |
| No | Gutter Run Slope (%) | 9.2 | | Road Cross Slope (%) | 5.9 |

Remove & Replace Curb Ramp With Two New Directional Ramps or Equivalent. Remove & Replace Gutter.
