# Access Compliance Report Public Rights-of-Way (Curb Ramps)

Main Street: CASSELLE\_AVE Cross Street: DUNAS\_RD Location: SE

ADA ID: RPAT211005095248 Ramp Type: Type 1 - Perpendicular Diagonal Initial Pass/Fail: Pass Overall Compliance: No Severity Score: 26

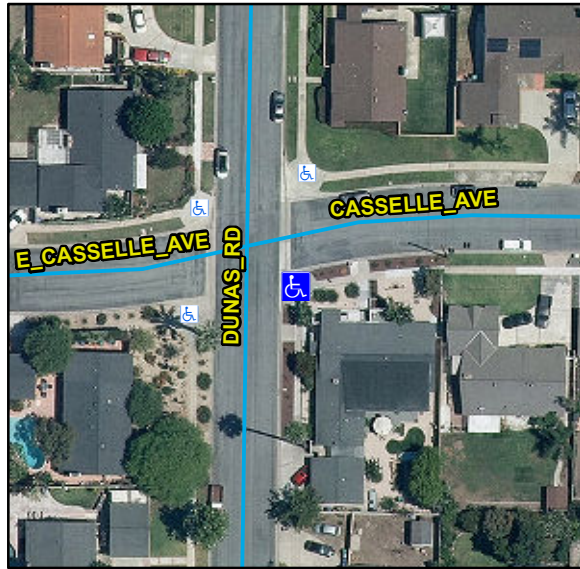
| Compliance | Description | Data | Compliance | Description | Data |
|---|---|---|---|---|---|
| No | Ramp Cross Slope (%) | 4.9 | N/A | Flare Traversable LT | No |
| No | Landing Width (in) | N/A | N/A | Flare Slope RT (%) | 1.3 |
| No | Landing Run Slope (%) | N/A | N/A | Flare Traversable RT | No |
| No | Landing Cross Slope (%) | N/A | No | DWS Provided | No |
| Yes | Gutter Ponding | No | No | Curb Slope | 8.6 |
| No | Gutter Run Slope (%) | 5.6 | | Road Cross Slope (%) | 4.4 |
| No | Gutter Cross Slope (%) | 5.1 | | | |

Remove & Replace Curb Ramp With Two New Directional Ramps or Equivalent. Remove & Replace Gutter.
