# Access Compliance Report Public Rights-of-Way (Curb Ramps)

Main Street: DUNAS\_RD Cross Street: ROMELLE\_AVE Location: NE

ADA ID: RPAT211005100343 Ramp Type: Type 1 - Perpendicular Diagonal Initial Pass/Fail: Fail Overall Compliance: No Severity Score: 16

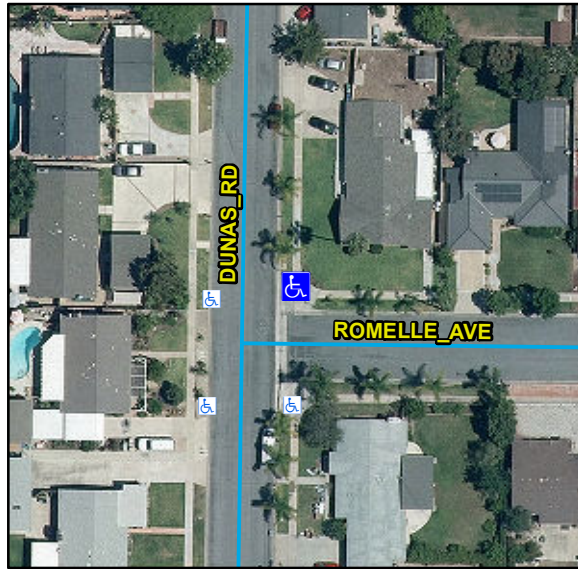
| Compliance | Description | Data | Compliance | Description | Data |
|---|---|---|---|---|---|
| No | Ramp Run Slope (%) | 8.4 | N/A | Flare Slope LT (%) | N/A |
| N/A | Gutter Ponding | N/A | No | Curb Slope | 8.2 |

**Remove & Replace Curb Ramp With Two New Directional Ramps or Equivalent.**

**R304.2.2, STD 1115**
