# Access Compliance Report Public Rights-of-Way (Curb Ramps)

Main Street: ROMELLE\_AVE Cross Street: DUNAS\_RD Location: SE

ADA ID: RPAT211005100821 Ramp Type: Type 1 - Perpendicular Diagonal Initial Pass/Fail: Pass Overall Compliance: No Severity Score: 22

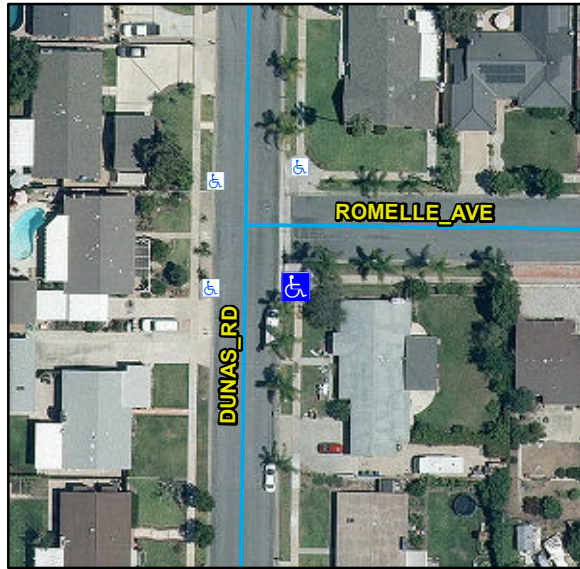
| Compliance | Description | Data | Compliance | Description | Data |
|---|---|---|---|---|---|
| No | Ramp Cross Slope (%) | 5 | N/A | Flare Traversable LT | No |
| No | Landing Width (in) | N/A | N/A | Flare Slope RT (%) | 1.2 |
| No | Landing Run Slope (%) | N/A | N/A | Flare Traversable RT | No |
| No | Landing Cross Slope (%) | N/A | No | DWS Provided | No |
| No | Gutter Cross Slope (%) | 3.4 | | | |

Remove & Replace Curb Ramp With Two New Directional Ramps or Equivalent. Remove & Replace Gutter.
