# Access Compliance Report Public Rights-of-Way (Curb Ramps)

Main Street: SWIDLER\_PL Cross Street: CASSELLE\_AVE Location: SW

ADA ID: RPAT211005102031 Ramp Type: Type 1 - Perpendicular Diagonal Initial Pass/Fail: Pass Overall Compliance: No Severity Score: 26

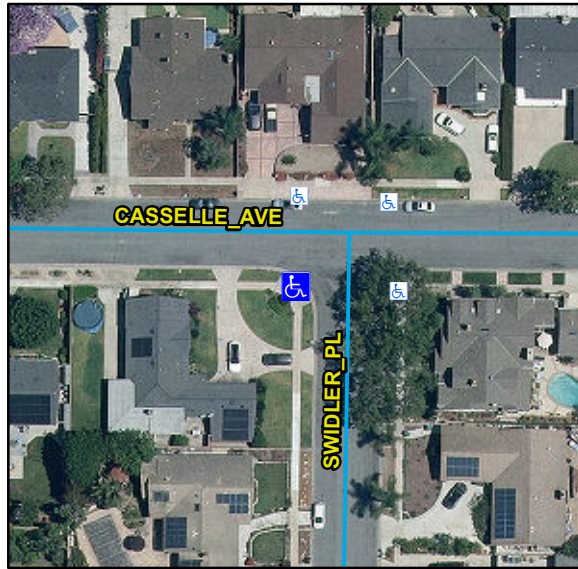
| Compliance | Description | Data | Compliance | Description | Data |
|---|---|---|---|---|---|
| No | Landing Cross Slope (%) | N/A | No | DWS Provided | No |
| Yes | Gutter Ponding | No | No | Curb Slope | 8.7 |
| No | Gutter Run Slope (%) | 7.1 | | Road Cross Slope (%) | 6.6 |

Remove & Replace Curb Ramp With Two New Directional Ramps or Equivalent. Remove & Replace Gutter.

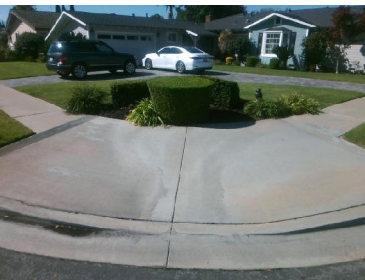
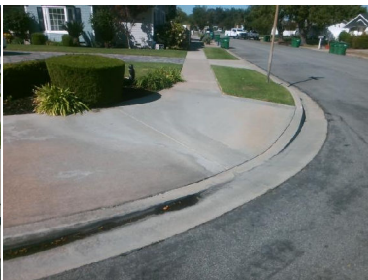
| Compliance | Description | Data | Compliance | Description | Data |
|---|---|---|---|---|---|
| Yes | Overall Surface Condition: Acceptable | | No | Perp Joint Present | No |
