# Access Compliance Report Public Rights-of-Way (Curb Ramps)

Main Street: CASSELLE\_AVE Cross Street: SWIDLER\_PL Location: SE

ADA ID: RPAT211005102649 Ramp Type: Type 1 - Perpendicular Diagonal Initial Pass/Fail: Fail Overall Compliance: No Severity Score: 2

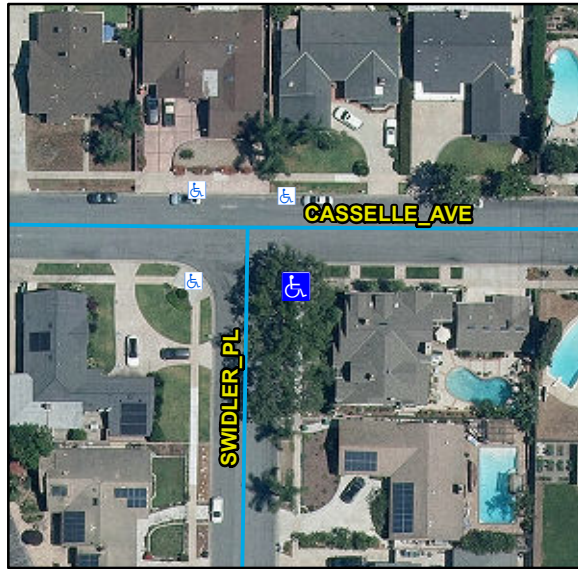
| Compliance | Description | Data | Compliance | Description | Data |
|---|---|---|---|---|---|
| No | Ramp Cross Slope (%) | 4.6 | N/A | Flare Traversable LT | N/A |

Remove & Replace Curb Ramp With Two New Directional Ramps or Equivalent.

R304.5.3, STD 1115
