Access Compliance Report Public Rights-of-Way (Curb Ramps)

Main Street: **S_WOODLAND_ST** Cross Street: **CASSELLE_AVE** Location: **SW**

ADA ID: **RPAT211005103033** Ramp Type: **Type 1 - Perpendicular Diagonal** Initial Pass/Fail: **Fail** Overall Compliance: **No** Severity Score: **2**

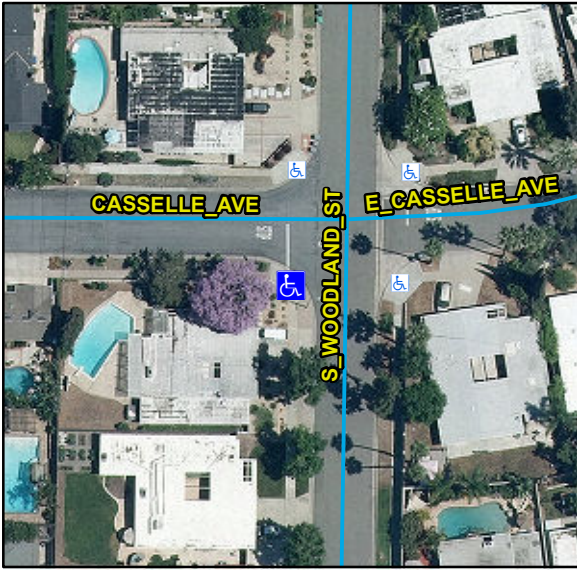
Compliance	Description	Data	Compliance	Description	Data
N/A	Ramp Length (in)	122	N/A	Flare Type LT	
Yes	Ramp Width (in)	48			N/A
Yes	Ramp Run Slope (%)	7.8	N/A	Flare Slope LT (%)	N/A
No	Ramp Cross Slope (%)	2.5	N/A	Flare Traversable LT	N/A
N/A	Landing Present	N/A	N/A	Flare Type RT	
N/A	Landing Length (in)	N/A			N/A
N/A	Landing Width (in)	N/A	N/A	Flare Slope RT (%)	N/A
N/A	Landing Run Slope (%)	N/A	N/A	Flare Traversable RT	N/A
N/A	Landing Cross Slope (%)	N/A	N/A	DWS Provided	N/A
N/A	Landing Movement Obstructed?	N/A	N/A	DWS Contrast	N/A
	Landing Movement Type	N/A	N/A	DWS Length (in)	N/A
N/A	Landing Shared	N/A	N/A	DWS Full Width	N/A
N/A	Clear Space	Yes	N/A	DWS Offset Left (in)	N/A
N/A	Clear Space To Crosswalk (in)	N/A	N/A	DWS Offset Right (in)	N/A
N/A	Marked Crosswalk 1	No	N/A	Marked Crosswalk 2	No
	Crossing 1 Direction	E		Crossing 2 Direction	N
	Marked Crosswalk 1 Width (in)	N/A		Marked Crosswalk 2 Width (in)	N/A

N/A	Ramp Inside Crosswalk 1	N/A	Yes	Ramp Inside Crosswalk 2	N/A
	Crossing 1 Slope (%)	0.8		Crossing 2 Slope (%)	5.1
	Crossing 1 Cross Slope (%)	2.2		Crossing 2 Cross Slope (%)	0.4
N/A	Gutter Ponding	N/A	No	Curb Slope	13.6
Yes	Gutter Lip Height (in)	0		Road Run Slope (%)	0.7
N/A	Gutter Run Slope (%)	N/A		Road Cross Slope (%)	3.3
N/A	Gutter Cross Slope (%)	N/A			
Yes	Overall Surface Condition: Acceptable		Yes	Perp Joint Present	Yes
	Cross Gutter Present?	No		Spandrel Present?	No
	Replace Cross Gutter?	N/A		Replace Spandrel?	N/A

Possible Solutions:
Remove & Replace Curb Ramp With Two New Directional Ramps or Equivalent.

OC Std/PROW:
R304.2.2, R304.5.3, STD 1115
