# Access Compliance Report Public Rights-of-Way (Curb Ramps)

Main Street: E CASSELLE\_AVE Cross Street: S\_WOODLAND\_ST Location: SE

ADA ID: RPAT211005103344 Ramp Type: Type 1 - Perpendicular Diagonal Initial Pass/Fail: Fail Overall Compliance: No Severity Score: 2

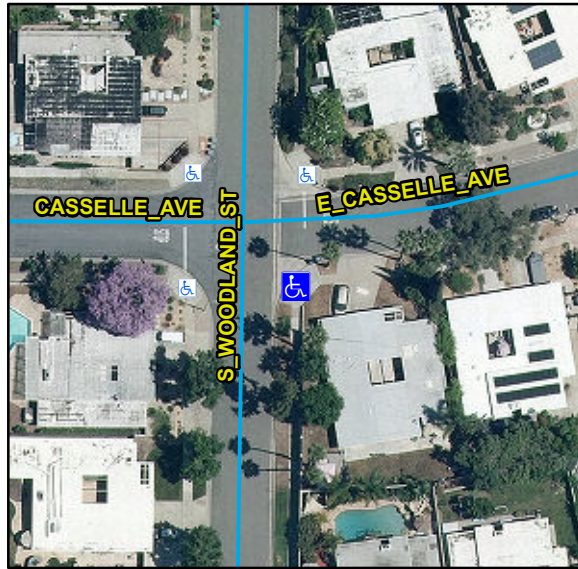
| Compliance | Description | Data | Compliance | Description | Data |
|---|---|---|---|---|---|
| No | Ramp Cross Slope (%) | 3.1 | N/A | Flare Traversable LT | N/A |

Remove & Replace Curb Ramp With Two New Directional Ramps or Equivalent.

R304.2.2, R304.5.3, STD 1115
