# Access Compliance Report Public Rights-of-Way (Curb Ramps)

Main Street: S\_WOODLAND\_ST Cross Street: E\_CASSELLE\_AVE Location: NE

ADA ID: RPAT211005103535 Ramp Type: Type 1 - Perpendicular Diagonal Initial Pass/Fail: Fail Overall Compliance: No Severity Score: 4

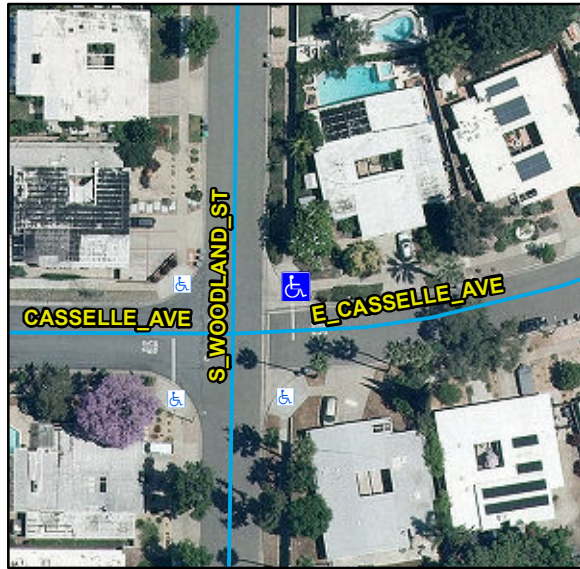
| Compliance | Description | Data | Compliance | Description | Data |
|---|---|---|---|---|---|
| No | Ramp Width (in) | 47 | | | N/A |
| N/A | Gutter Ponding | N/A | No | Curb Slope | 14.5 |

**Remove & Replace Curb Ramp With Two New Directional Ramps or Equivalent.**

**R304.2.2, R304.5.1, STD 1115**
