# Access Compliance Report Public Rights-of-Way (Curb Ramps)

Main Street: CASSELLE\_AVE Cross Street: S\_WOODLAND\_ST Location: NW

ADA ID: RPAT211005103744 Ramp Type: Type 1 - Perpendicular Diagonal Initial Pass/Fail: Pass Overall Compliance: No Severity Score: 25

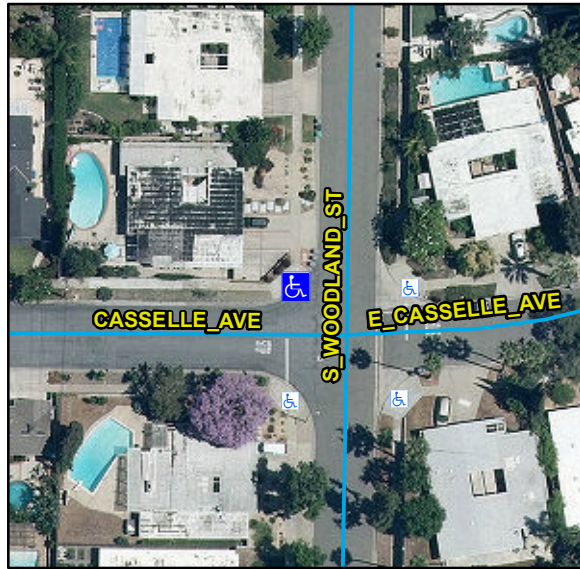
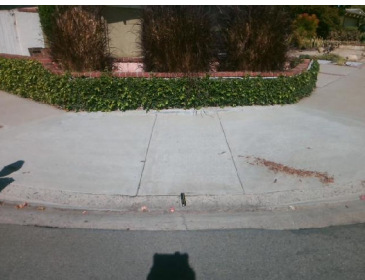
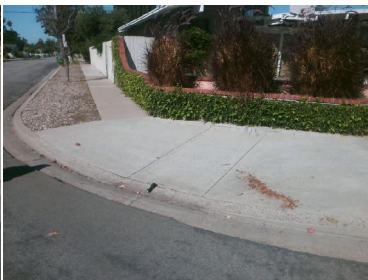
| Compliance | Description | Data | Compliance | Description | Data |
|---|---|---|---|---|---|
| No | Landing Width (in) | N/A | Yes | Flare Slope RT (%) | 6.3 |
| No | Landing Run Slope (%) | N/A | N/A | Flare Traversable RT | Yes |
| No | Landing Cross Slope (%) | N/A | No | DWS Provided | No |
| Yes | Gutter Ponding | No | No | Curb Slope | 13.7 |
| No | Gutter Run Slope (%) | 8.6 | | Road Cross Slope (%) | 2.2 |
| No | Gutter Cross Slope (%) | 9 | | | |

Remove & Replace Curb Ramp With Two New Directional Ramps or Equivalent. Remove & Replace Gutter.
