# Access Compliance Report Public Rights-of-Way (Curb Ramps)

Main Street: LARKSTONE\_DR Cross Street: S\_WOODLAND\_ST Location: NW

ADA ID: RPAT211005121952 Ramp Type: Type 1 - Perpendicular Diagonal Initial Pass/Fail: Fail Overall Compliance: No Severity Score: 4

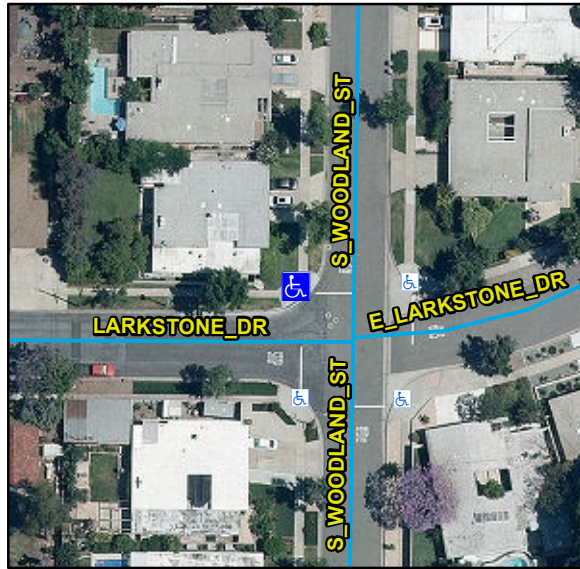
| Compliance | Description | Data | Compliance | Description | Data |
|---|---|---|---|---|---|
| No | Ramp Width (in) | 47 | | | N/A |
| N/A | Gutter Ponding | N/A | No | Curb Slope | 26.1 |

Remove & Replace Curb Ramp With Two New Directional Ramps or Equivalent.

R304.2.2, R304.5.1, STD 1115
