# Access Compliance Report Public Rights-of-Way (Curb Ramps)

Main Street: S\_WOODLAND\_ST Cross Street: E\_LARKSTONE\_DR Location: NE

ADA ID: RPAT211005122823 Ramp Type: Type 1 - Perpendicular Diagonal Initial Pass/Fail: Fail Overall Compliance: No Severity Score: 4

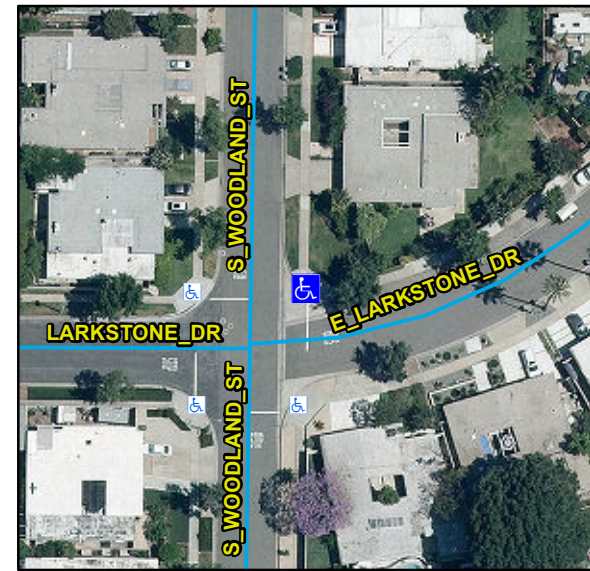
| Compliance | Description | Data | Compliance | Description | Data |
|---|---|---|---|---|---|
| No | Ramp Width (in) | 47 | | | N/A |

Possible Solutions:  
**Remove & Replace Curb Ramp With Two New Directional Ramps or Equivalent.**

OC Std/PROW:  
**R304.2.2, R304.5.1, STD 1115**
