# Access Compliance Report Public Rights-of-Way (Curb Ramps)

Main Street: LARKSTONE\_DR Cross Street: SWIDLER\_PL Location: NW

ADA ID: RPAT211005123655 Ramp Type: Type 1 - Perpendicular Diagonal Initial Pass/Fail: Pass Overall Compliance: No Severity Score: 20

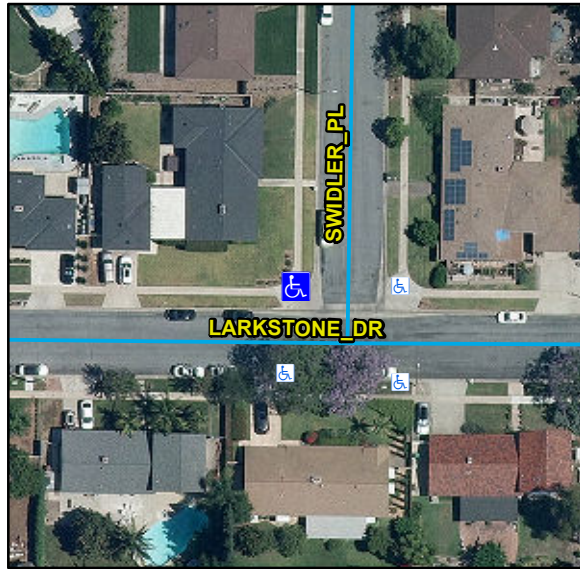
| Compliance | Description | Data | Compliance | Description | Data |
|---|---|---|---|---|---|
| No | Landing Width (in) | N/A | N/A | Flare Slope RT (%) | 7.9 |
| No | Landing Run Slope (%) | N/A | N/A | Flare Traversable RT | No |
| No | Landing Cross Slope (%) | N/A | No | DWS Provided | No |

Remove & Replace Curb Ramp With Two New Directional Ramps or Equivalent.
