# Access Compliance Report Public Rights-of-Way (Curb Ramps)

Main Street: CURRIE\_CIR Cross Street: ERVIN\_LN Location: NE

ADA ID: RPAT211005140339 Ramp Type: Type 1 - Perpendicular Diagonal Initial Pass/Fail: Fail Overall Compliance: No Severity Score: 4

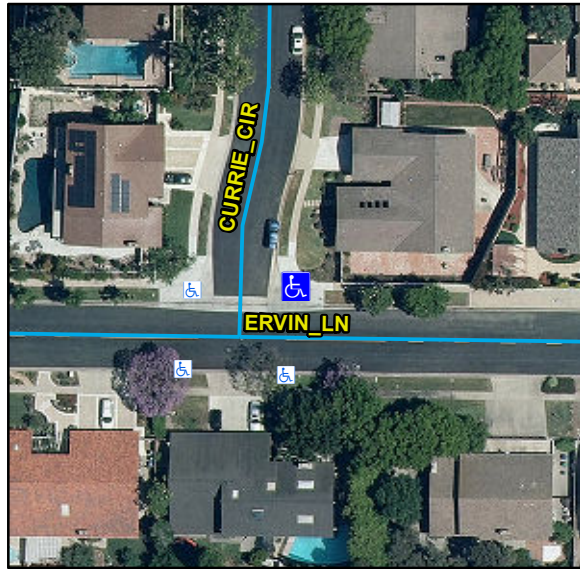
| Compliance | Description | Data | Compliance | Description | Data |
|---|---|---|---|---|---|
| No | Ramp Width (in) | 47 | | | N/A |

**Remove & Replace Curb Ramp With Two New Directional Ramps or Equivalent.**

**R304.5.1, STD 1115**
