Access Compliance Report Public Rights-of-Way (Curb Ramps)

Main Street: JENET_CIR **Cross Street:** ERVIN_LN **Location:** NE

ADA ID: RPAT211005140919 **Ramp Type:**Type 1 - Perpendicular Diagonal Initial Pass/Fail: Fail **Overall Compliance:** No **Severity Score:** 5

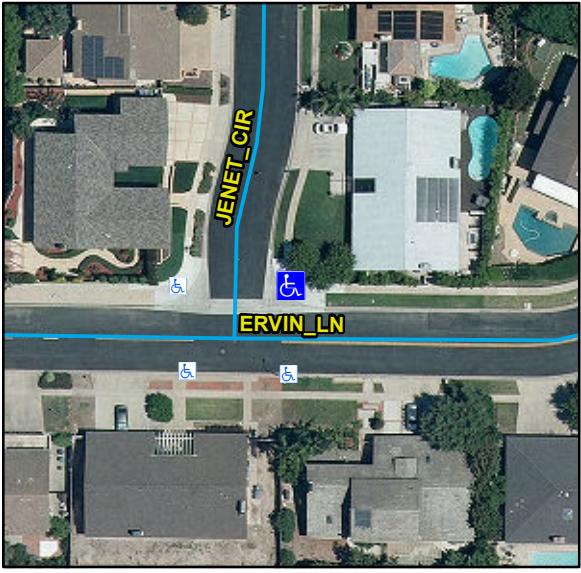
Compliance	Description	Data	Compliance	Description	Data
N/A	Ramp Length (in)	69	N/A	Flare Type LT	
No	Ramp Width (in)	47			N/A
Yes	Ramp Run Slope (%)	7.9	N/A	Flare Slope LT (%)	N/A
Yes	Ramp Cross Slope (%)	0.5	N/A	Flare Traversable LT	N/A
N/A	Landing Present	N/A	N/A	Flare Type RT	
N/A	Landing Length (in)	N/A			N/A
N/A	Landing Width (in)	N/A	N/A	Flare Slope RT (%)	N/A
N/A	Landing Run Slope (%)	N/A	N/A	Flare Traversable RT	N/A
N/A	Landing Cross Slope (%)	N/A	N/A	DWS Provided	N/A
N/A	Landing Movement Obstructed?	N/A	N/A	DWS Contrast	N/A
	Landing Movement Type	N/A	N/A	DWS Length (in)	N/A
N/A	Landing Shared	N/A	N/A	DWS Full Width	N/A
N/A	Clear Space	Yes	N/A	DWS Offset Left (in)	N/A
N/A	Clear Space To Crosswalk (in)	N/A	N/A	DWS Offset Right (in)	N/A
N/A	Marked Crosswalk 1	No	N/A	Marked Crosswalk 2	No
	Crossing 1 Direction	W		Crossing 2 Direction	S
	Marked Crosswalk 1 Width (in)	N/A		Marked Crosswalk 2 Width (in)	N/A

Possible Solutions:
Remove & Replace Curb Ramp With Two New Directional Ramps or Equivalent.

OC Std/PROW:
R304.5.1, STD 1115

Total Cost: \$ 6160
