# Access Compliance Report Public Rights-of-Way (Curb Ramps)

Main Street: ERVIN\_LN Cross Street: TEA\_HOUSE\_ST Location: NW

ADA ID: RPAT211005145857 Ramp Type: Type 3 - Combination 1 Initial Pass/Fail: Fail Overall Compliance: No Severity Score: 16

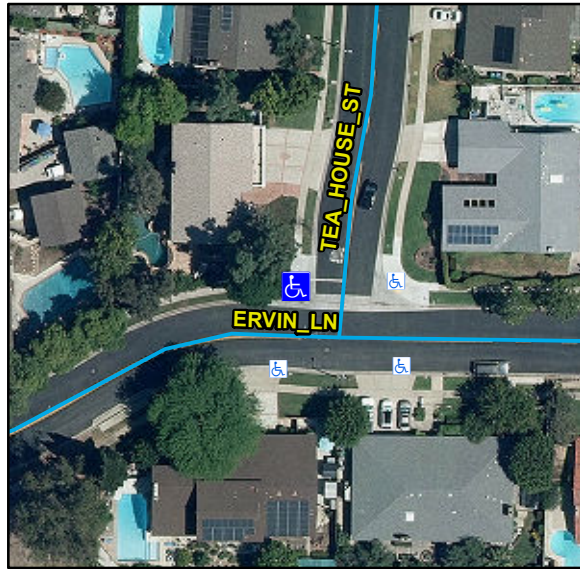
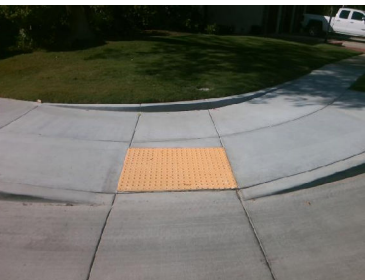
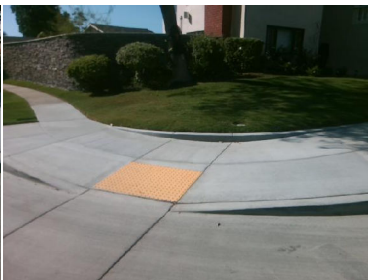
| Compliance | Description | Data | Compliance | Description | Data |
|---|---|---|---|---|---|
| Yes | Ramp Run Slope LT (%) | 1.4 | No | Ramp Run Slope RT (%) | 8.7 |
| Yes | Ramp Cross Slope LT (%) | 0.6 | No | Ramp Cross Slope RT (%) | 3.3 |

**Remove & Replace Curb Ramp With Two New Directional Ramps or Equivalent.**

**R304.3.2, R304.5.3, STD 1115**
