# Access Compliance Report Public Rights-of-Way (Curb Ramps)

Main Street: JUDY\_ANN\_LN Cross Street: ERVIN\_LN Location: NE

ADA ID: RPAT211005151132 Ramp Type: Type 1 - Perpendicular Diagonal Initial Pass/Fail: Pass Overall Compliance: No Severity Score: 6

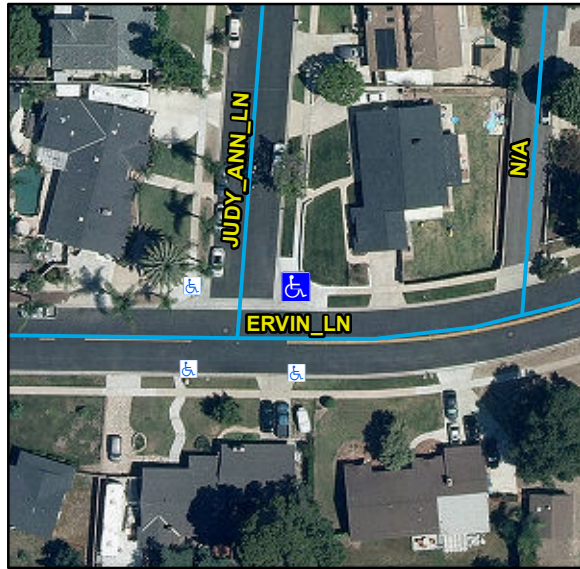
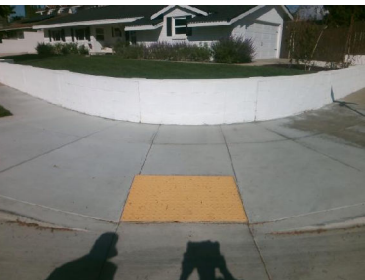
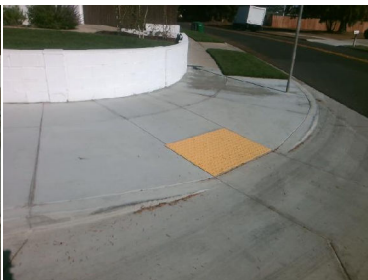
| Compliance | Description | Data | Compliance | Description | Data |
|---|---|---|---|---|---|
| No | Landing Width (in) | 47 | N/A | Flare Slope RT (%) | 6.6 |
| N/A | Landing Movement Obstructed? | Yes | Yes | DWS Contrast | Yes |
| | Landing Movement Type | Wall | Yes | DWS Length (in) | 36 |

Remove & Replace Landing.

R304.2.1, STD 1115
