# Access Compliance Report Public Rights-of-Way (Curb Ramps)

Main Street: ERVIN\_LN Cross Street: JUDY\_ANN\_LN Location: NW

ADA ID: RPAT211005151600 Ramp Type: Type 1 - Perpendicular Diagonal Initial Pass/Fail: Fail Overall Compliance: No Severity Score: 5

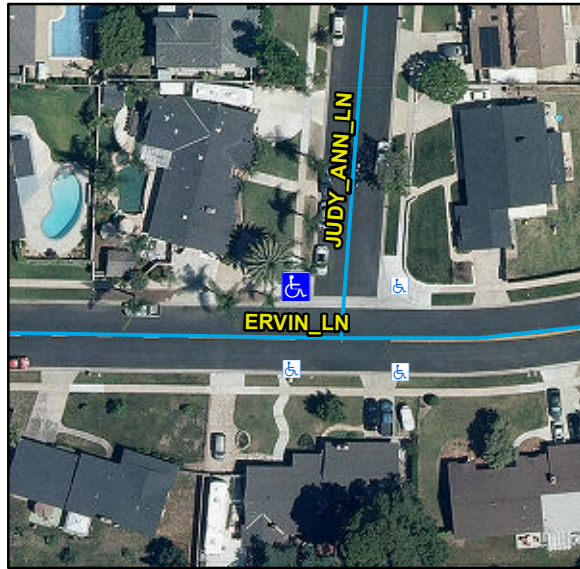
| Compliance | Description | Data | Compliance | Description | Data |
|---|---|---|---|---|---|
| No | Ramp Width (in) | 47 | | | N/A |

Remove & Replace Curb Ramp With Two New Directional Ramps or Equivalent.

R304.5.1, STD 1115
