# Access Compliance Report Public Rights-of-Way (Curb Ramps)

Main Street: GERSHON\_PL Cross Street: VANDERLIP\_AVE Location: NE

ADA ID: RPAT211006085843 Ramp Type: Type 1 - Perpendicular Diagonal Initial Pass/Fail: Fail Overall Compliance: No Severity Score: 5

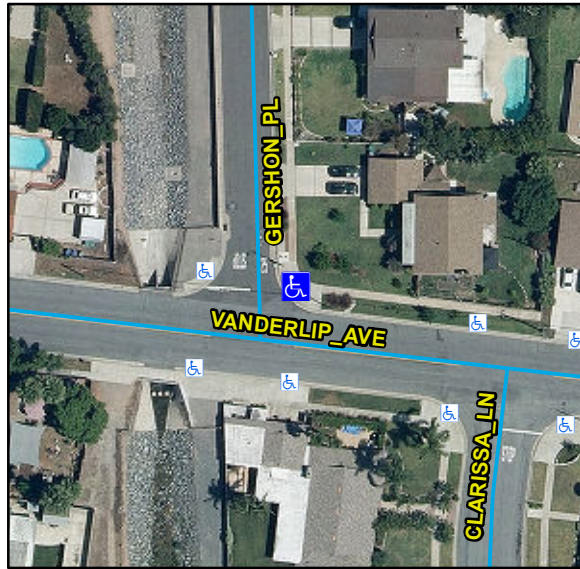
| Compliance | Description | Data | Compliance | Description | Data |
|---|---|---|---|---|---|
| No | Ramp Width (in) | 47 | | | N/A |

Remove & Replace Curb Ramp With Two New Directional Ramps or Equivalent.

R204.3, R304.5.1, STD 1115

Total Cost: \$ 6160
