# Access Compliance Report Public Rights-of-Way (Curb Ramps)

Main Street: VANDERLIP\_AVE Cross Street: GERSHON\_PL Location: NW

ADA ID: RPAT211006090147 Ramp Type: Blended Transition 2 Initial Pass/Fail: Fail Overall Compliance: No Severity Score: 32

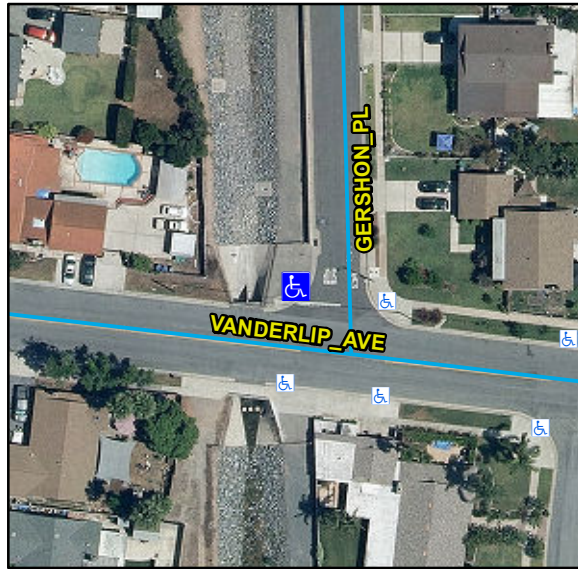
| Compliance | Description | Data | Compliance | Description | Data |
|---|---|---|---|---|---|
| No | Ramp Run Slope (%) | 14.9 | N/A | Flare Slope RT (%) | N/A |
| No | Ramp Cross Slope (%) | 3 | N/A | Flare Traversable RT | N/A |

Remove & Replace Curb Ramp With Two New Directional Ramps or Equivalent.

R304.2.2, R304.5.3, STD 1115
