# Access Compliance Report Public Rights-of-Way (Curb Ramps)

Main Street: CLARISSA\_LN Cross Street: VANDERLIP\_AVE Location: SW

ADA ID: RPAT211006090536 Ramp Type: Type 1 - Perpendicular Diagonal Initial Pass/Fail: Fail Overall Compliance: No Severity Score: 15

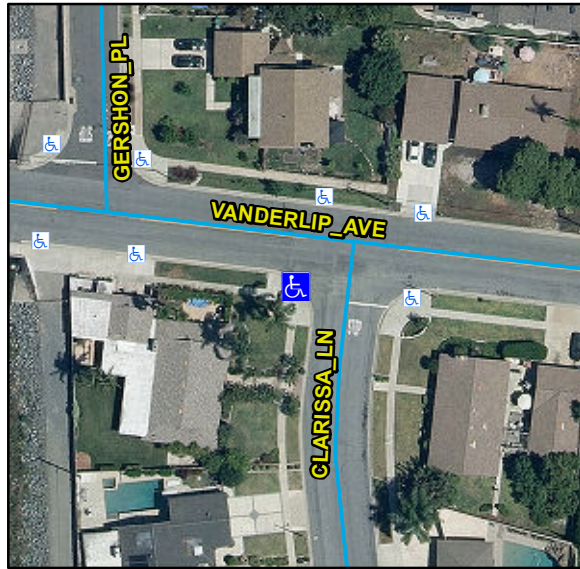
| Compliance | Description | Data | Compliance | Description | Data |
|---|---|---|---|---|---|
| No | Ramp Run Slope (%) | 9.3 | N/A | Flare Slope LT (%) | N/A |

Remove & Replace Curb Ramp With Two New Directional Ramps or Equivalent.

R304.2.2, STD 1115
