# Access Compliance Report Public Rights-of-Way (Curb Ramps)

Main Street: VANDERLIP\_AVE Cross Street: CLARISSA\_LN Location: SE

ADA ID: RPAT211006090800 Ramp Type: Type 1 - Perpendicular Diagonal Initial Pass/Fail: Fail Overall Compliance: No Severity Score: 15

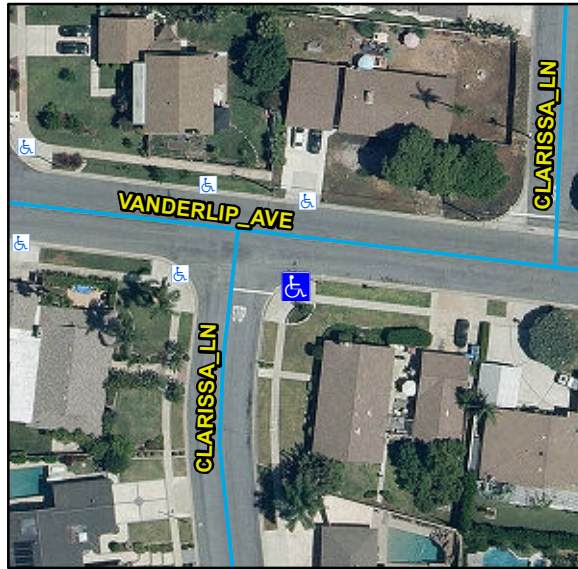
| Compliance | Description | Data | Compliance | Description | Data |
|---|---|---|---|---|---|
| No | Ramp Run Slope (%) | 9 | N/A | Flare Slope LT (%) | N/A |

Remove & Replace Curb Ramp With Two New Directional Ramps or Equivalent.

R204.3, R304.2.2, STD 1115
