# Access Compliance Report Public Rights-of-Way (Curb Ramps)

Main Street: VANDERLIP\_AVE Cross Street: VANDERLIP\_AVE Location: N

ADA ID: RPAT211006091907 Ramp Type: Type 1 - Perpendicular Initial Pass/Fail: Pass Overall Compliance: No Severity Score: 15

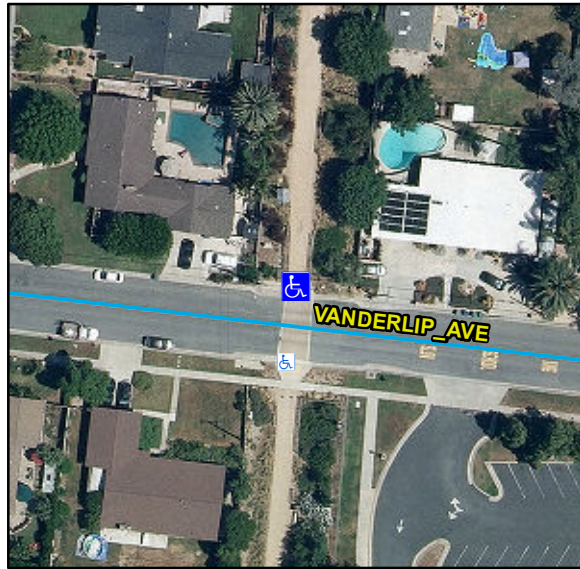
| Compliance | Description | Data | Compliance | Description | Data |
|---|---|---|---|---|---|
| No | Landing Width (in) | N/A | N/A | Flare Slope RT (%) | 25.4 |
| No | Landing Run Slope (%) | N/A | N/A | Flare Traversable RT | No |
| No | Landing Cross Slope (%) | N/A | Yes | DWS Provided | Yes |
| N/A | Landing Movement Obstructed? | Yes | Yes | DWS Contrast | Yes |
| | Landing Movement Type | dirt trail | Yes | DWS Length (in) | 48 |
| No | Gutter Run Slope (%) | 12.7 | | Road Cross Slope (%) | N/A |

Remove & Replace Entire Ramp. Remove & Replace Gutter.
