# Access Compliance Report Public Rights-of-Way (Curb Ramps)

Main Street: VANDERLIP\_AVE Cross Street: BRENAN\_WAY Location: SW

ADA ID: RPAT211006092644 Ramp Type: Type 1 - Perpendicular Initial Pass/Fail: Pass Overall Compliance: No Severity Score: 19

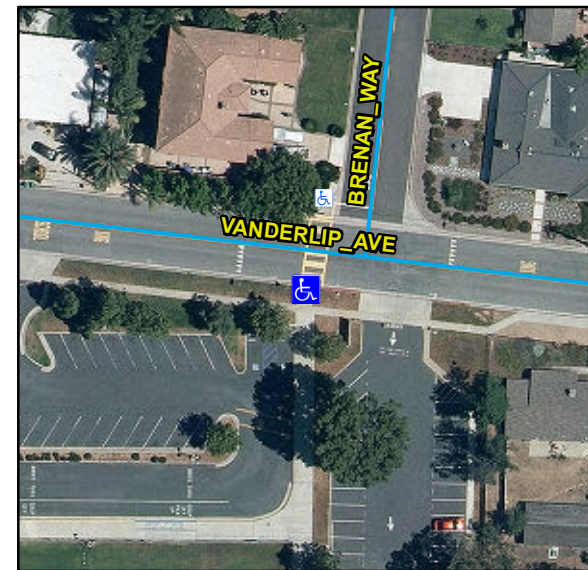
| Compliance | Description | Data | Compliance | Description | Data |
|---|---|---|---|---|---|
| No | Landing Width (in) | 45 | N/A | Flare Slope RT (%) | 17.3 |
| Yes | Landing Cross Slope (%) | 1.3 | No | DWS Provided | No |
| Yes | Gutter Ponding | No | No | Curb Slope | 23.3 |
| No | Gutter Run Slope (%) | 12 | | Road Cross Slope (%) | N/A |

Remove & Replace Entire Ramp. Remove & Replace Gutter.
