# Access Compliance Report Public Rights-of-Way (Curb Ramps)

| Main Street: VANDERLIP_AVE | | Cross Street: BRENAN_WAY | | Location: | NW |
| ADA ID: RPAT211006093011 | Ramp Type: Type 4 - Parallel | Initial Pass/Fail: Fail | Overall Compliance: No | Severity Score: | 15 |

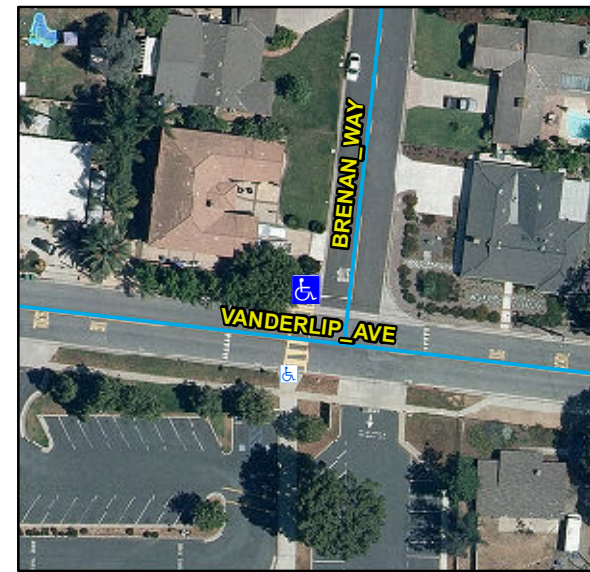
| Compliance | Description | Data | Compliance | Description | Data |
|---|---|---|---|---|---|
| Yes | Ramp Run Slope LT (%) | 7.6 | No | Ramp Run Slope RT (%) | 9.9 |

Possible Solutions:

Remove & Replace Entire Ramp.

R304.3.2, STD 1115
