# Access Compliance Report Public Rights-of-Way (Curb Ramps)

Main Street: N/A Cross Street: VANDERLIP\_AVE Location: SE

ADA ID: RPAT211006094256 Ramp Type:Type 1 - Perpendicular Initial Pass/Fail: Fail Overall Compliance: No Severity Score: 16

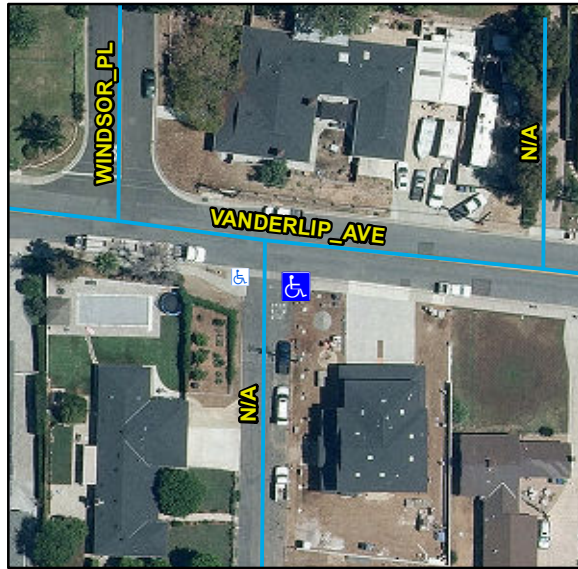
| Compliance | Description | Data | Compliance | Description | Data |
|---|---|---|---|---|---|
| No | Ramp Run Slope (%) | 9.1 | N/A | Flare Slope LT (%) | N/A |
| No | Ramp Cross Slope (%) | 3.5 | N/A | Flare Traversable LT | N/A |

Remove & Replace Entire Ramp.

R204.3, R304.2.2, R304.5.3, STD 1115
